FIELD SERVICE NEWS

FUJI HEAVY INDUSTRIES LTD.

NO : FAN-031

IMPROVEMENT OF PARKING CONTROL CABLE ASSY

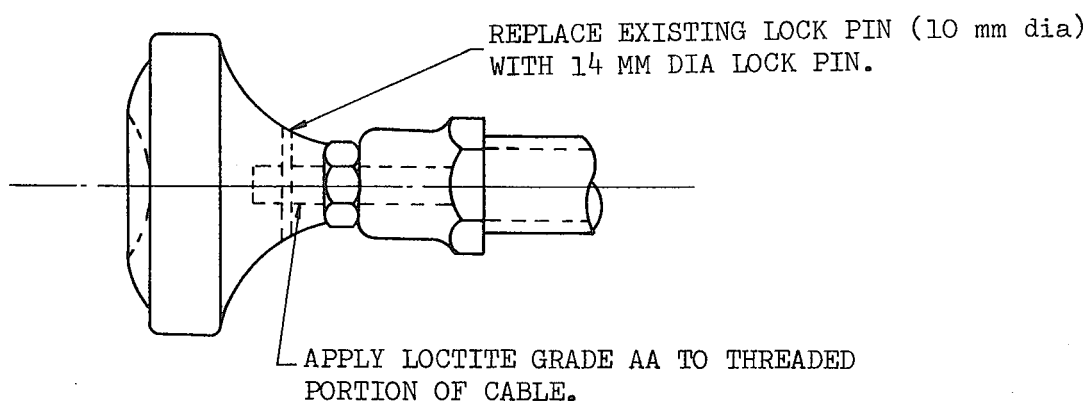
There have been a few instances reported whereby the pilot failed to operate the parking control cable assy since failure of the knob lock pin occurred due to overtightening and resulted in idle rotation of the knob. The following improvements have been made to preclude failure of the lock pin. Model FA-200 Aircraft, S/N 202 and subsequent and spare parts will have this modification accomplished prior to delivery.

1. The diameter of the lock pin has been increased to 1.4 mm from 1.0 mm.
2. Loctite grade AA has been applied to the threaded portion of the cable.

1. Drill out the existing pin with 1.2 mm dia drill.
2. Remove the cable from the knob. Apply loctite Grade AA to the threaded portion as shown in the accompanying figure, and reinstall the cable into the knob.
3. Drill through the knob and cable with 1.4 mm dia drill.
4. Cut 1.4 mm dia music wire (JIS G 3522 SWPA or equivalent) to a proper length (approximately 15 mm) in order to make a lock pin.
5. Insert the lock pin into the hole, and stake around the ends of the pin.
