SERVICE BULLETIN

FUJI HEAVY INDUSTRIES LTD.

NO : FAS-012A

1. SUBJECT : Inspection of battery.
2. AIRCRAFT AFFECTED: FA-200 Series Aircraft, S/Ns 12 thru 127, equipped with P/N 200-383600-001 battery. | A
3. PRIORITY : Essential.
4. REASON : Battery installation should be inspected for fear that electrolytic fluid leak in case of overfilling or inadequate installation of battery cover.
5. DESCRIPTION : Inspect the battery installation. Work procedure and inspection item are described in No. 13 and No. 14. Have a contact to Fuji H. I., if electrolyte leakage is found.
6. ACCOMPLISHMENT : As soon as reception of this service bulletin and at all 50 hr inspection thereafter.
7. APPROVAL : JCAB Approval (No. 315) January 21, 1969
8. PARTS REQUIRED : Nothing.
9. SPECIAL TOOLS : Nothing.
10. WEIGHT AND BALANCE: No change.
11. REFERENCE : Nothing.
12. MANPOWER : 1 MH.

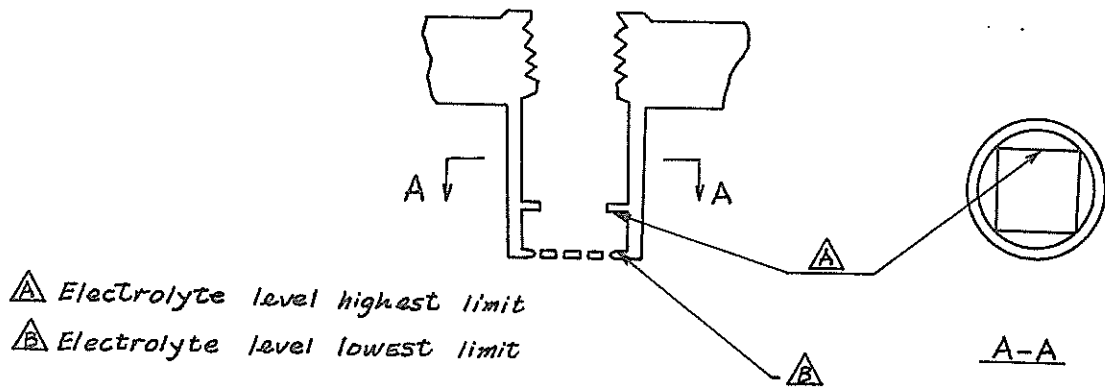
Fig. 1

- (1) Check the battery and fuselage structure rear the battery for leakage of electrolyte.
- (2) Charge the battery and check the electrolyte level. Electrolyte level should be within mark A and B (Refer to Fig. 1).
- (3) Tighten battery cell filler caps and check the leakage from the filler caps in upside down condition.
- (4) Check the rim around the battery box for detachment. The rim height should be more than 2 mm (0.08 inch) from the rubber seal. (Fig. 2)
- (5) Check the battery cover for crack.
- (6) Check the vent pipe for the gap between the pipe and cover.
- (7) Install the battery and adjust the clamp screw as there is no gap between the battery cover and rubber seal.
- (8) Cut the tip of outboard side vent tube under fuselage as illustrated in Fig. 3.
