SERVICE BULLETIN

FUJI HEAVY INDUSTRIES, LTD.

NO. FAS-017 A

Reinforcement of fuselage skin around the bearings

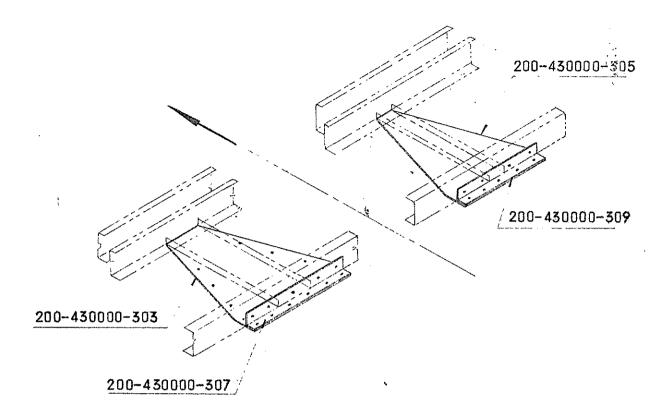
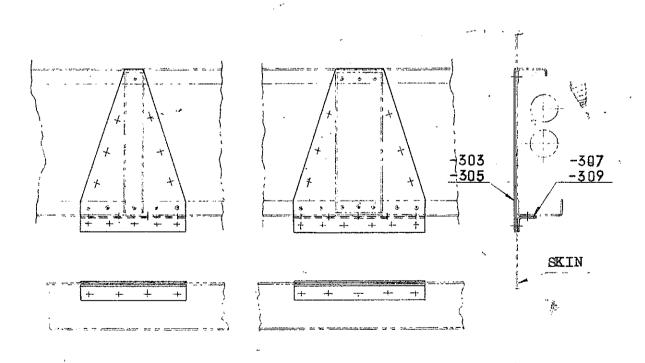
(FAS-017) SHEET 3 OF 3

4. REASON: In order to protect the fuselage skin around the

two outboard bearings of rudder pedal torque tubes

from crack.

- (4) Remove the floor panels, taking out all rivets which fix the panels to structure.
- (5) Reinforce the skin around the two outboard bearings of rudder pedal torque tube in accordance with the illustration.

- Note: 1. Be careful not to damage the torque tube or other parts, when taking out the rivets.
 - 2. Blind rivet may be used, when it is difficult to rivet the doubler to the frame.

- 3. At the bolts fixing the bearings, make the bolts size holes on the doubler and fasten the bolts with doublers, but at the rivet between the bolts, make a large hole not to interfere to the rivet head.
