SERVICE BULLETIN

Fuji Heavy Industries Ltd.

NO. FAS-036

MODIFICATION OF FRONT LANDING GEAR.

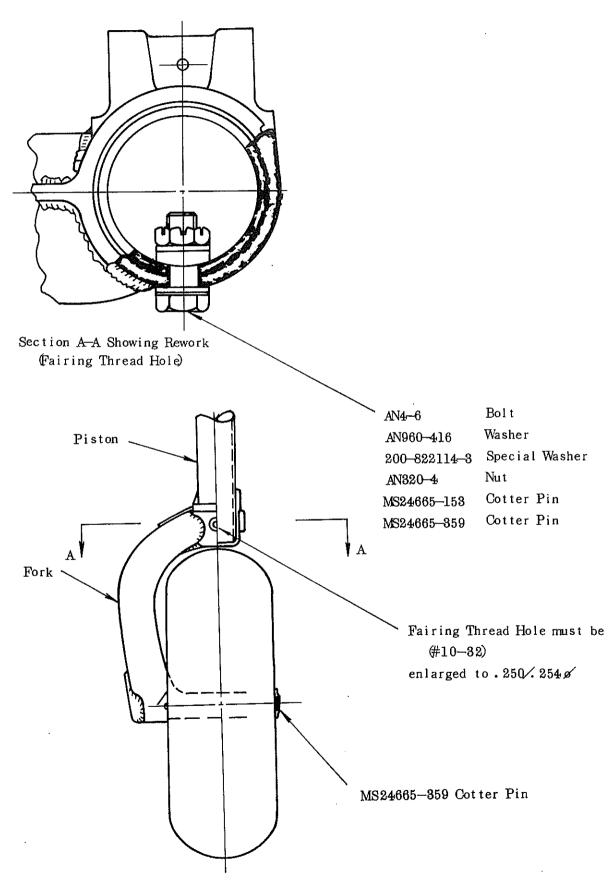
Figure 1. Front Landing Gear Assy (View Looking Aft)

In order to improve safety of front landing gear.

A hole to be installed in the thermal fitting portion of piston and fork of the subject assy.

- Jack up front landing gear, and remove tire.
 Using 1/4^b drill, enlarge the fairing thread hole to .250/.254^b.
- 2) Apply wet zinc chromate primer to the hole after removing burrs.
- 3) Insert hole, AN4-6, with washer, AN960-416.
- 4) Install special washer, 200-822114 -3, as shown in Figure 1. with its radius mated to radius of piston inside, and also install washer, AN960-416.

Torque nut, AN320-4, and secure with cotter pin, MS24665-153.

5) Install tire and remove jack.
Use new cotter pin, MS24665-359.
