## SERVICE BULLETIN

FUJI HEAVY INDUSTRIES LTD.

NO : FAS-065

1. SUBJECT : Modification of Main Landing Gear Assemblies.

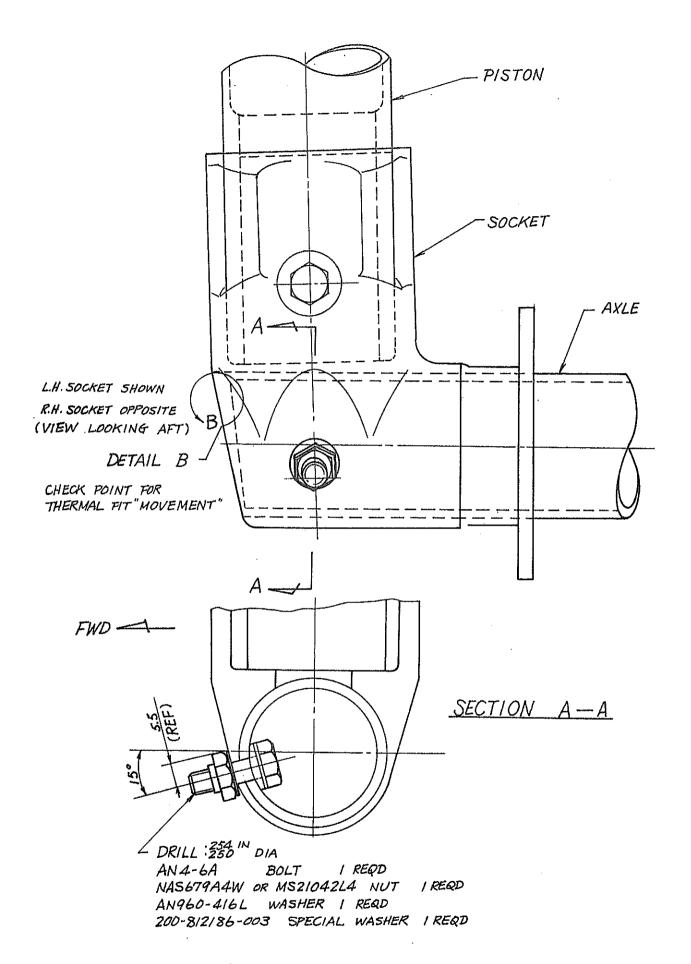
FAS - 065 FIGURE 1. MODIFICATION OF MAIN LANDING GEAR

(An instance was reported where the axle slipped off from the thermal fitted socket.)

- (1) Clean the end of socket bore, and check for evidence of axial movement of axle. (See figure 1, detail B.)
- (2) If axial movement more than 2 mm is evident in the above inspection, contact Fuji Heavy Industries Ltd. immediately.
- (3) If no movement is found, accomplish modification as follows:

- (1) Jack up main landing gear.
- (2) Drill 0.250 to 0.254 inch diameter hole in socket and axle assy as illustrated in figure 1.
- (3) Remove all burrs, then apply wet zinc chromate primer to hole surfaces.
- (4) Insert AN4-6 bolt into hole with 200-812186-003 special washer. Position special washer against axle inside with radius of washer mated to radius of axle.
- (5) Install AN960-416L washer, and tighten NAS679A4W\_or MS21042L4 nut.
- (6) Lower main landing gear.

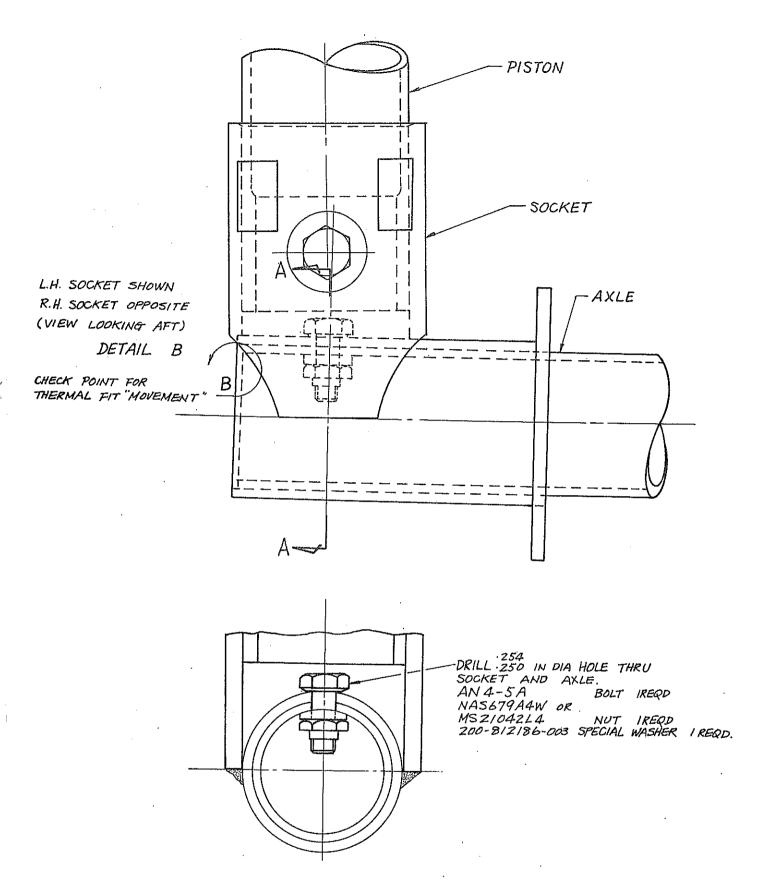
# FIGURE 2. MODIFICATION OF MAIN LANDING GEAR (APPLICABLE TO S/Ns 2 THRU 11)

- (1) Clean the end of socket bore, and check for evidence of axial movement of axle. (See figure 2, detail B.)
- (2) If axial movement more than 2 mm is evident in the above inspection, contact Fuji Heavy Industries Ltd. immediately.
- (3) If no movement is found, accomplish modification as follows:

- (1) Jack up airframe and remove tire.
- (2) Remove piston and socket attaching bolt and lower end of torque link, and then remove socket and axle assy.
- (3) Drill 0.250 to 0.254 inch diameter hole in socket and axle assy as illustrated in figure 2.
- (4) Remove all burrs, then apply wet zinc chromate primer to hole surfaces.
- (5) Insert AN4-5A bolt into hole from piston side as illustrated.
- (6) Position 200-812186-003 special washer against axle inside with radius of washer mated to radius of axle, then tighten NAS679A4W or MS21042L4 nut.
- (7) Install socket and axle assy, and connect lower end of torque link, using new cotter pin MS24665-132.
- (8) Install tire and secure with new cotter pin MS24665-360.
- (9) Lower airframe and remove jack.
