SERVICE BULLETIN

FUJI HEAVY INDUSTRIES LTD.

NO. 200-003 DATE November 7, 1981 (SUPERSEDES NO. 200-003)
REV. B DATE September 18, 1991 (SUPERSEDES NO. 200-003A)
REASON To change priority, modification requirement, etc.

1. SUBJECT	: Inspection and Modification of F.STA 7105 Bulkhead and Replacement of Bracket.
2. AIRCRAFT AFFECTED	: All FA-200 aircraft
3. PRIORITY	: Mandatory

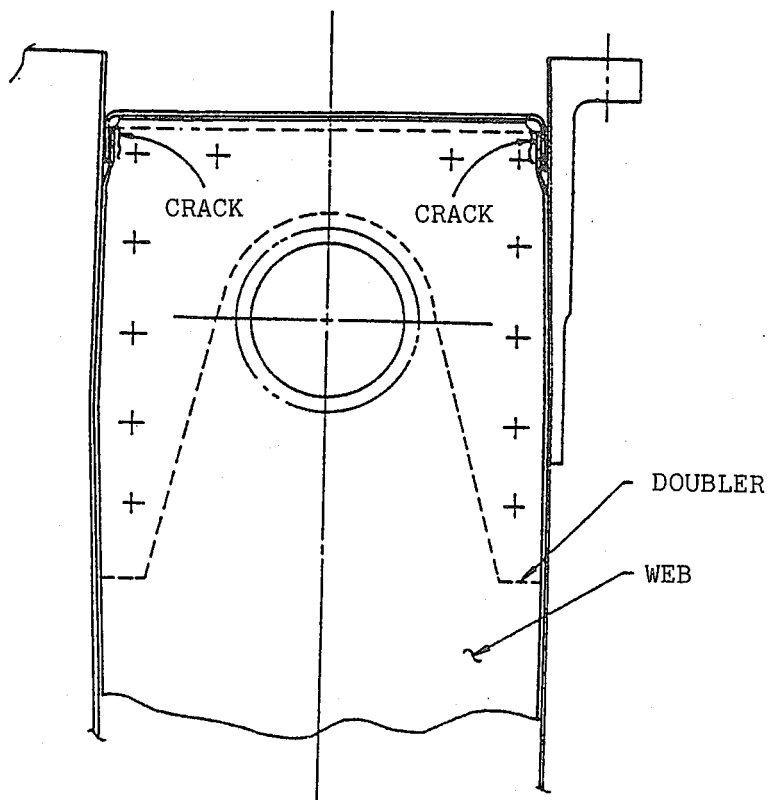
FIGURE 2. (VIEW A-A) F.STA 7105 BULKHEAD

4. REASON	: (1) There have been instances reported whereby cracks have been found in the upper corners of F.STA 7105 bulkhead web and doubler. As a result of investigation, it has been determined that inspection and modification are required. (2) Since there have been instances reported whereby cracks have been found in the both left and right corners of the bracket added per SB No. 200-003, replacement of the bracket is required.

(1) Inspection of F.STA 7105 (Reference figure 2):

- (c) Inspect F.STA 7105 bulkhead web for cracks. (see figure 2 for crack suspected areas.) It is recommended that a small inspection mirror be used through the rudder cable thru hole (as shown in figure 1) for this inspection.
- (d) Inspect aft side (doubler) of the above bulkhead for cracks. Use a suitable mirror through access hole in the upper tail cone web.
