# SERVICE BULLETIN

NO. 200-005

1. SUBJECT : Introduction of Teijin Seiki Service Bulletin No. TS-SB-72 (Inspection and Modification of Teijin Seiki Fuel Strainer P/N FIF-40000)
2. AIRCRAFT AFFECTED : All FA200-160, 180 and 180A aircraft equipped with fuel strainer specified by Teijin Seiki S.B. No. TS-SB-72.

NO. TS-SB-72      DATE 1-10-84  
REV                      DATE  
                            REASON

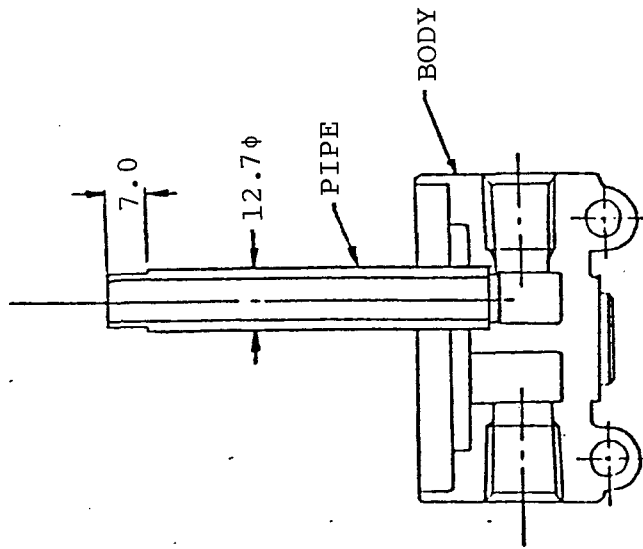
Strainer, repair work not required

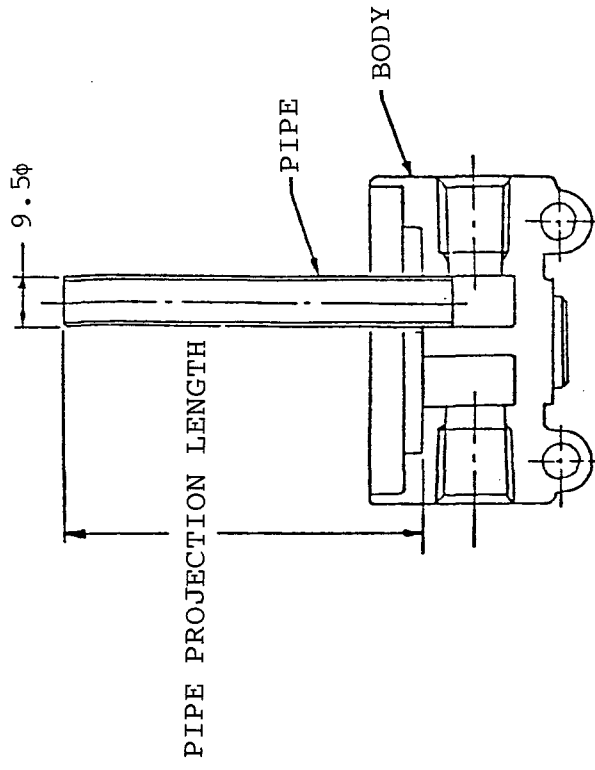
Fig.-1

In connection with some particular model of FIF40000 Fuel Strainer, there is slight chance of its piece part; FIF40008 pipe becoming loose in the body, which might result in fuel-blockade.

Condition; loose pipe and/or pipe which projects less than 62mm from the surface of the body.

Strainer, repair work required

All Fuel Strainers, requiring repair as a result of above inspection, shall be repaired per Phase 2 procedure within next 25 flight hours, except Fuel Strainer which exhibits condition described below shall be repaired before next flight.

Phase 2 : The repair work is to replace the pipe with FIF40020 pipe.
