SERVICE BULLETIN

NO. 200-008

1. SUBJECT : Inspection of Control Column Gust Lock Pin Holes
2. AIRCRAFT AFFECTED : All FA200 series aircraft except airplanes modified in accordance with Technical Bulletin 200-020.

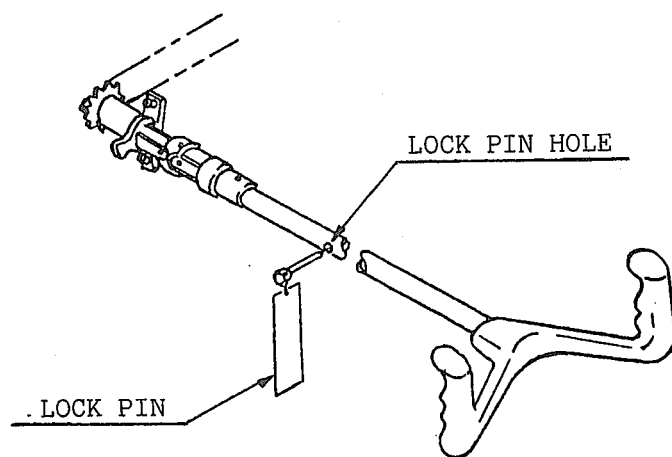
FIGURE 1 CONTROL COLUMN

3. PRIORITY : MANDATORY
4. REASON : There has been an instance reported whereby a section of the control column assembly fractured during an aerobatic flight. The fracture, resulting from fatigue crack, occurred at the gust lock pin holes. In the interest of flight safety, this bulletin requires inspection of the affected area.

11. REFERENCE : Not applicable.
12. DETAILED INSTRUCTIONS:
 - (1) Pull control column at left seat, and clean the lock pin hole area of control tube.
 - (2) Using 10x magnifying glass, inspect the lock pin hole and adjacent area for cracks. Pay particular attention to the radial directions (perpendicular to the axis of tube) of hole.

- (3) If burr is found at hole, dress with small round file. If crack is found, replace the affected control column with new control column assembly with tube of increased strength installed.
