SERVICE BULLETIN

FUJI HEAVY INDUSTRIES LTD.

NO. 200-009

1. SUBJECT : Inspection and Repair of Elevator Torque Tube
2. AIRCRAFT AFFECTED : All FA-200 series aircraft S/N 12 and subsequent
3. PRIORITY : Essential.

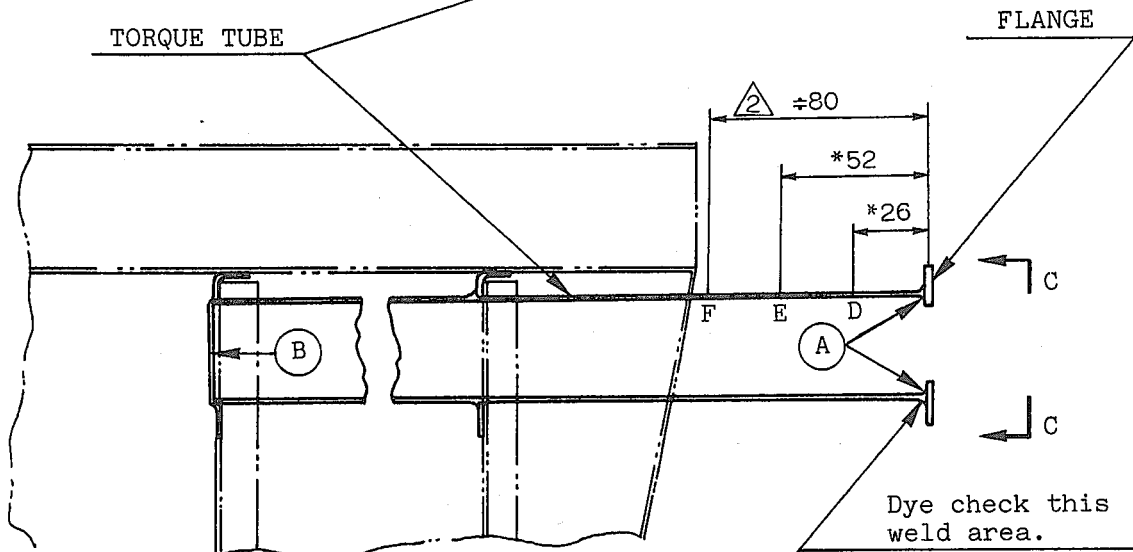
FIGURE 1

Thoroughly remove corrosion, particularly corrosion at the internal corner of flange. (See figure 1, area (A).)

- (6) Using a bore scope or mirror, inspect the internal surfaces to ensure corrosion has been cleaned up.
- (7) After corrosion clean up, measure wall thickness of elevator torque tube using ultrasonic thickness gage as specified in the preceding "9. SPECIAL TOOL" block.
Measure wall thickness in \triangle area of figure 1. Measurements should be taken at diameters D, E, and F with at least four (4) circumferential points equally apart.
- (8) Dye check the weld area, at the inboard end of tube, for crack.
- (9) If any measurement per above step (7) is 0.5mm or less, replace elevator torque tube with like item. If any measurement is more than 0.5mm and inspection per above step (7) reveals no cracks, proceed with the following steps:

- (10) A small hole is existing in the plate at the outboard end of elevator torque tube. (See figure 1, area (B).) Plug this hole with ProSeal 890 B-2 or equivalent. (Apply sealant to the tip of a long rod, and plug the hole.)

After inspection and repair,
bond glass cloth to flange
surface.

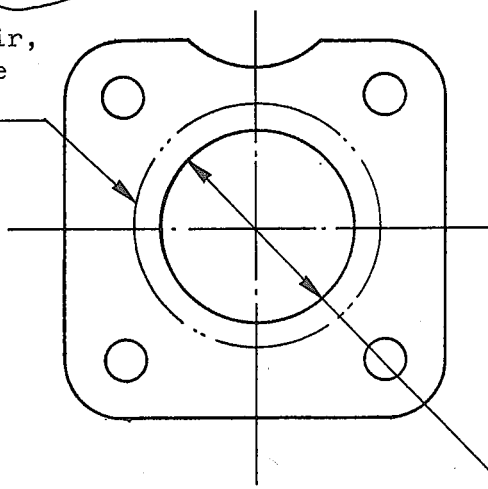
VIEW C-C

- (1) Remove elevator in accordance with Service Manual, Paragraph 8-5-1.
- (2) Drill 30mm diameter hole in flange at the inboard end of elevator torque tube. (See figure 1, view C-C.)
- (3) Using a bore scope or mirror, inspect the internal surfaces of elevator torque tube for evidence of corrosion or unusual condition.
- (4) If no corrosion is found on the internal surfaces, proceed with step (10).
- (5) If corrosion is found, remove corrosion using wire brush or rotary brush.

30mm diameter
inspection hole

- (11) Apply zinc chromate primer or equivalent to the internal surface of tube.
 - (12) Cover 30 mm diameter hole, drilled per above step (2), with glass cloth impregnated with EPON 828 or equivalent adhesive.
