SERVICE BULLETIN

FUJI HEAVY INDUSTRIES LTD.

NO. 200-010 DATE March 6, 1992 (SUPERSEDES NO.)
REV. DATE (SUPERSEDES NO.)
REASON

1. SUBJECT : HORIZONTAL STABILIZER FORWARD SPAR WEB, INSPECTION AND REPAIR OF
2. AIRCRAFT AFFECTED : All FA-200 series aircraft prior to S/N 12.
3. PRIORITY : Mandatory
4. REASON : Since there has been an instance reported whereby cracks occurred on the horizontal stabilizer forward spar web (center area), inspection and (if necessary) repair are required for the affected area.
5. DESCRIPTION : Visually inspect the horizontal stabilizer forward spar web for cracks. If inspection reveals crack(s), add both repair doubler and reinforcement doubler. If no cracks are found, install reinforcement doubler only.
6. ACCOMPLISHMENT : Immediately upon receipt of this bulletin.
7. APPROVAL : JCAB approval (No. Tokyo-3-010) February 17, 1992
8. PARTS REQUIRED : The following parts are required to comply with this bulletin:

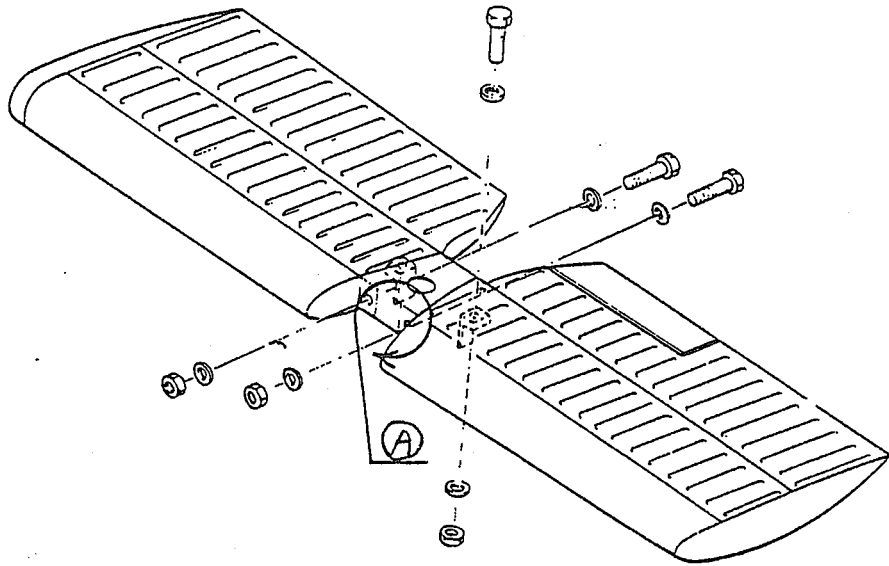
FIGURE 1

- (1) Remove horizontal stabilizer in accordance with Service Manual, para 7-6.
- (2) Visually inspect the center area of horizontal stabilizer forward spar web for cracks, paying particular attention to the circled A area as shown in the figure 1.
