TECHNICAL BULLETIN

NO. 200-017

: Canopy Rear Roller Rail Wear, Repair of

2. AIRCRAFT AFFECTED : FA-200 S/N 12 through 214

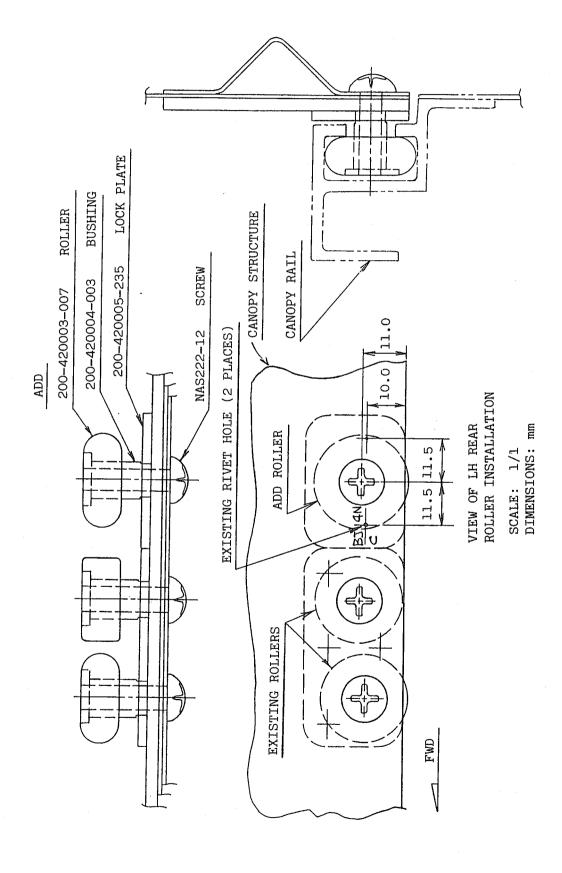
FIGURE 1. REWORK OF WEAR AT CANOPY REAR ROLLER RAIL

: To provide a repair scheme for wear at the canopy

: If repair is required by inspection, rework canopy

- 12. ACCOMPLISHMENT INSTRUCTIONS:
 - (1) Fully close canopy.
 - With a suitable marking pen, mark the portion of canopy rail which is aligned with canopy rear roller position.
 - (3) Fully open canopy.
 - Inspect the marked portion of canopy rail for wear. (see figure 1.) If wear is found, remove canopy in accordance with FA-200 Service Manual, Paragraph 7-4-1. Rework the worn area smoothly as indicated on Figure 1. (Remove material minimum as required.)

- (5) If rail flange material (dimension "a" on Figure 1, View A-A) is completely removed, after rework of excessively worn area, additional installation of roller is required in accordance with the following steps (6) through (8). Even if material removed is less than the above, add roller if lateral (axial) play is excessive.
- (6) Attach lockplate (200-420005-235) to canopy as shown in Figure 2.
- (7) Remove canopy rail stop. Install bushing (200-420004-003) into roller (200-420003-007). Engage the bushing and roller in rail, and then reinstall rail stop.
- (8) Reinstall canopy in accordance with FA-200 Service Manual, Paragraph 7-4-2. Secure the added roller in the same manner as the existing two rollers.
- 13. COMPLIANCE RECORD: After repair has been completed, make entries in aircraft log book.
