TECHNICAL BULLETIN

FUJI HEAVY INDUSTRIES LTD.

NO. 200-023

1. SUBJECT : Flap Hinge Fitting and Main Landing Gear Fitting, Corrosion Inspection/Repair of
2. AIRCRAFT AFFECTED : All FA-200 series aircraft.
3. PRIORITY : Desirable

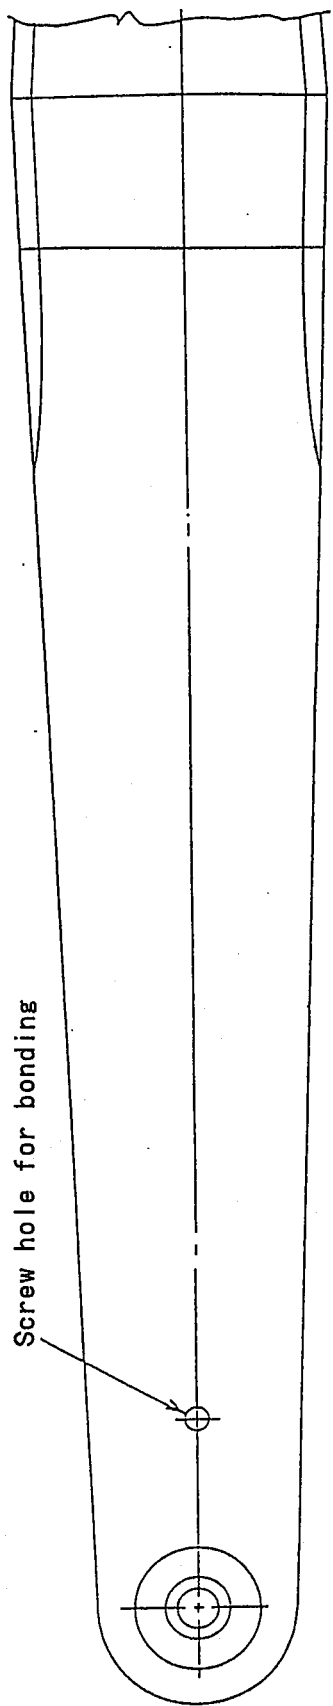
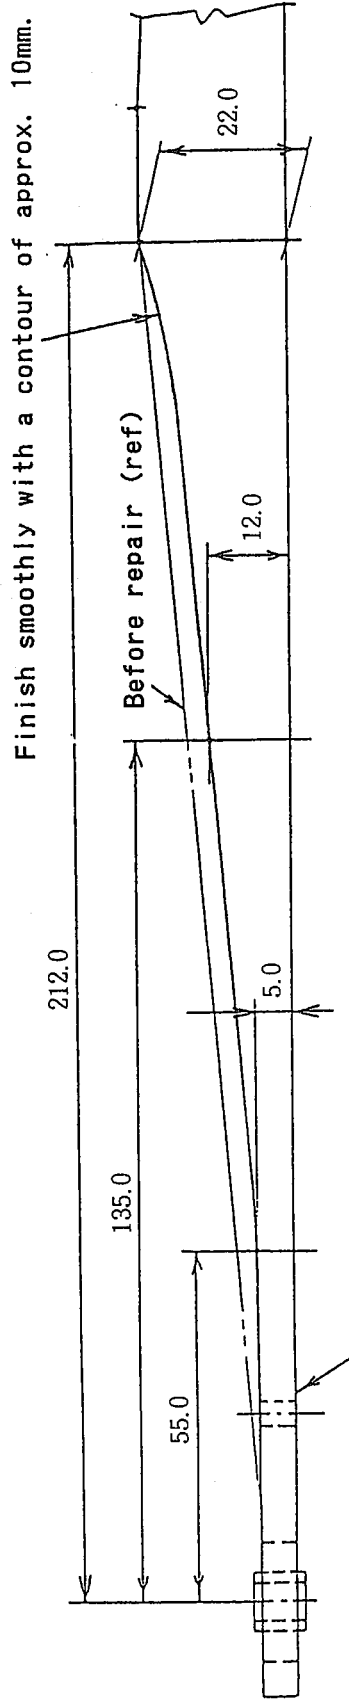
FIGURE 2 REPAIR LIMITS - FA-200 OUTBOARD FLAP HINGE FITTING

This side surface may be removed, provided minimum thickness is maintained.

- Remove only enough material to completely eliminate the corrosion.
 - Blend edges of repaired area into surrounding surface with a smooth contour.
 - The inside corner radius (R) of main landing gear shall be 10 mm or greater.
6. Dimensionally inspect repaired area to ensure Repair Limits (as shown in Figures 1 through 3) are not exceeded. If Repair Limits are exceeded contact FHI (for further engineering evaluation).
 7. Prime and finish paint repaired area.
It is recommended that chemical film treatment (alodine) be applied for corrosion protection prior to painting. Prime and finish paint to match surrounding areas.
 8. (If removed) install main landing gear and flap in accordance with Service Manual, paragraphs 9-3-2 and 8-3-2.

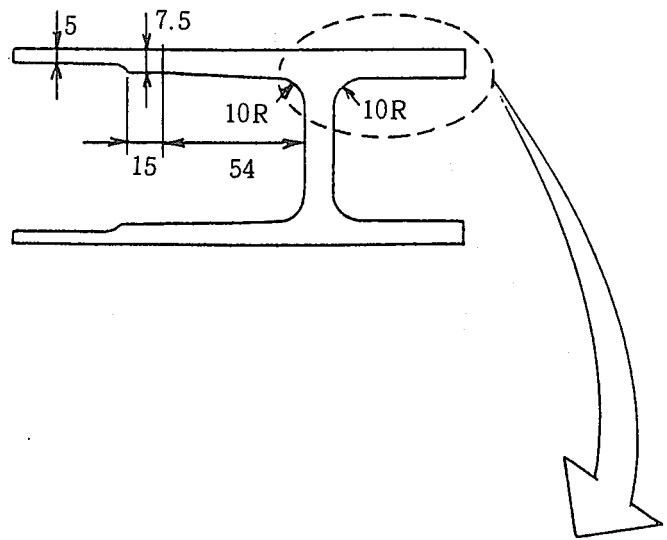
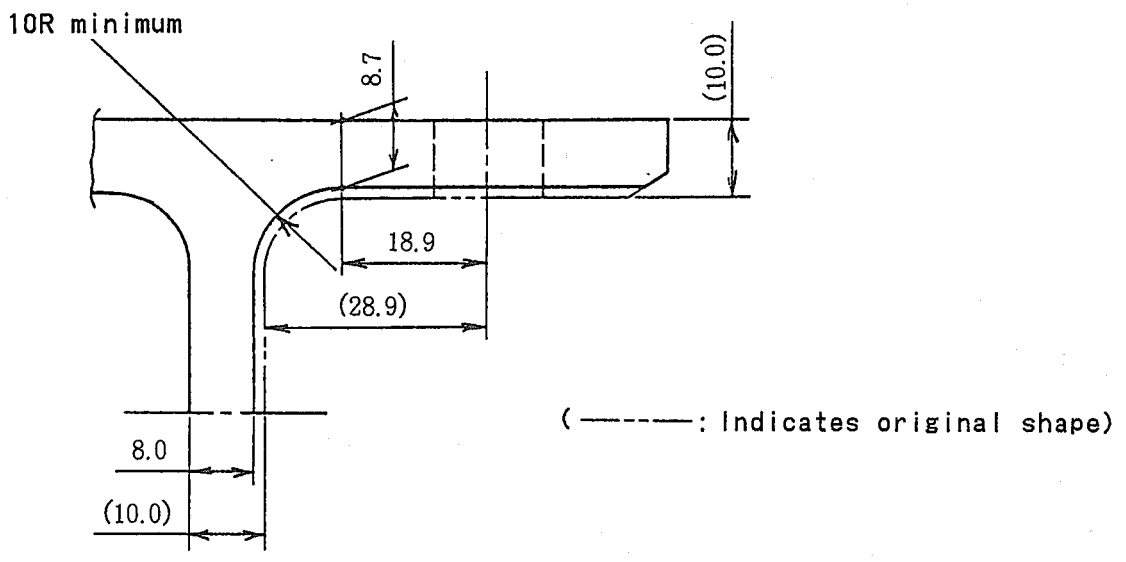
FIGURE 3 REPAIR LIMITS - MAIN LANDING GEAR FITTING

Dimensions show repair limits; The dimensions given in parentheses are the original dimensions.

- If a lateral gap has occurred between main landing gear strut fitting and main landing gear fitting, do not install main landing gear in this condition. To fill the gap, use shim as described below:
- If corrosion is removed from the surface mating with main landing gear strut fitting, use shim washer(s) between main landing gear and main landing gear fitting at installation. Thickness of shim washer(s) shall be equal to the amount of corrosion removal. Use of shim shall be displayed by appropriate marking in the adjacent area.
