富士重工業株式会社

発行番号 FAN-004

Dry Air Pump 駆動部オイルシールの交換
および真空系統リリーフバルブのカラゲ線追加について

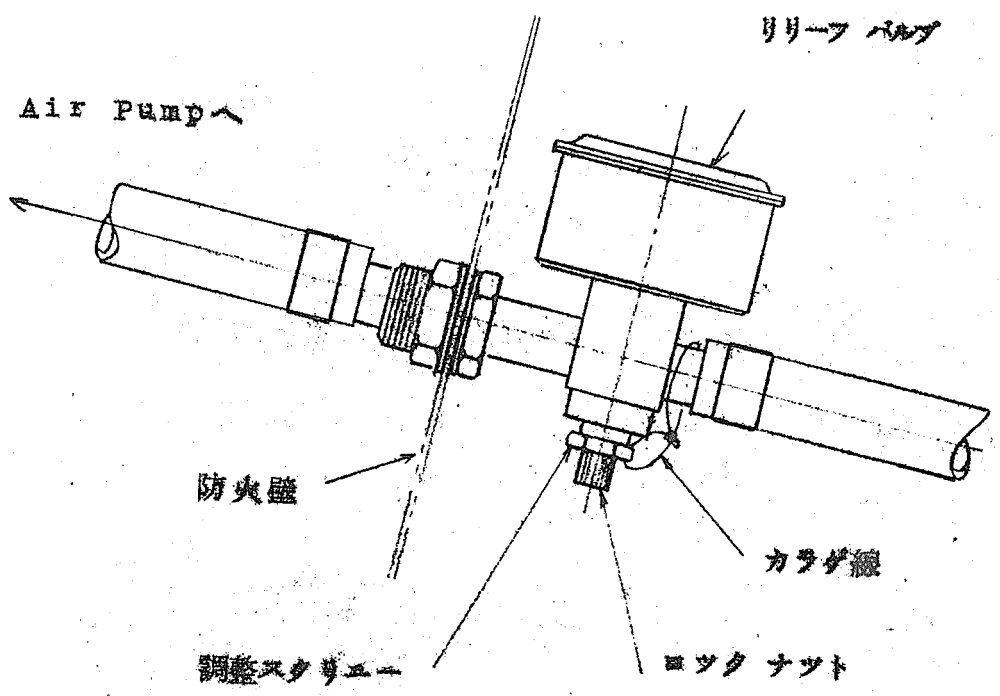
リリースバルブ調整後、調整スクリューのロックナットを締めわすれるとロックナットが脱落することがある。

エンジン回転1900R.P.Mで真空計の指示が4.2 INHgであることを確認する。

リリースバルブの調整は調整スクリューのロックナットをゆるめて行う。

調整スクリューを時計方向に廻すと吸引圧力が増す。

リリースバルブの調整が完了したらロックナットを確実に締めてカラゲ線をする。
