## FUJI HEAVY INDUSTRIES LTD.

NO : FAN-018

## FA-200 MAIN LANDING GEAR

## INSTALLING DIRECTION OF WHEEL ASSEMBLY SEAL

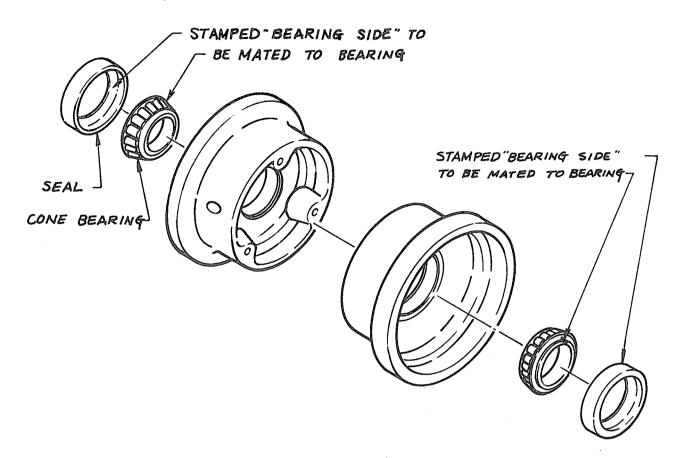
FIG. I BEARING AND SEAL ASSEMBLY

It is necessary to disassemble the wheel assembly in order to replace tire or to lubricate bearings, P/N: 13889. When reassembling removed parts, the seal, P/N: 9524218, may be installed incorrectly, with its metal surface mated to bearing. If this occurs, the seal will rotate and be damaged in a short time. This may also impart damage to the mating bearing, resulting in an accident.

It is, therefore, requested that the following instruction should be strictly observed: (See figure 1.)

Install seal, P/N: 9524218, with stamped "BEARING SIDE" mated to bearing, P/N: 13889.
