FIELD SERVICE NEWS

FUJI HEAVY INDUSTRIES LTD.

NO : FAN-030

INSTALLATION PROCEDURES FOR EMERGENCY SIGNAL BOX

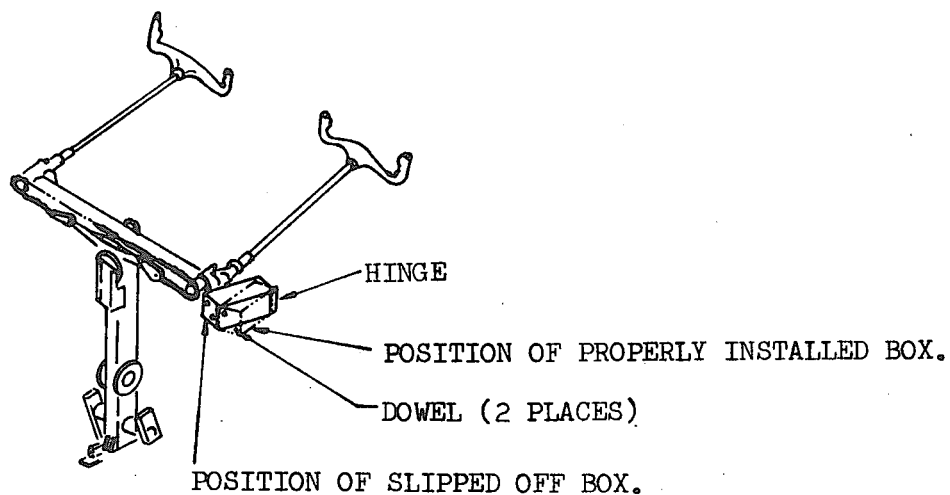
There has been an instance reported whereby the emergency signal box slipped off the attaching bracket on the firewall during taxiing, and interfered with the aileron chain as shown in the accompanying figure. As a result, the slipped box prevented the pilot from pulling the control wheel.

A close investigation revealed that the store box had not been correctly secured to the attaching bracket on the firewall - the two dowels not inserted in the mating holes in the bracket. It has been also confirmed that such a failure will never occur if the box is seated firmly in place.

It is, therefore, requested that the emergency signal box be installed properly in accordance with the procedures stated belows:

1. Check the attaching bracket and dowel insert holes for general conditions.
2. Check the hinge on structure for general conditions.
3. Check the hinge and dowels on the store box for general conditions.
4. Move L.H. fwd seat to the most rearward position.
5. Insert the two dowels into the mating holes in the bracket.
6. Make sure that the dowels are inserted in holes; then, align hinge loop holes and insert the hinge pin in place.
7. By shaking it with hand, check to assure that the box is seated firmly in place.
