SERVICE BULLETIN

FUJI HEAVY INDUSTRIES LTD.

NO. 200-011 DATE March 6, 1992 (SUPERSEDES NO.)
REV. DATE (SUPERSEDES NO.)
REASON

1. SUBJECT : Inspection of Flap Control Lever Pawl Rod
2. AIRCRAFT AFFECTED : All FA200 series aircraft
3. PRIORITY : Essential
4. REASON : Since there has been an instance reported whereby the flap control lever pawl rod failed, an inspection is required of the affected area.

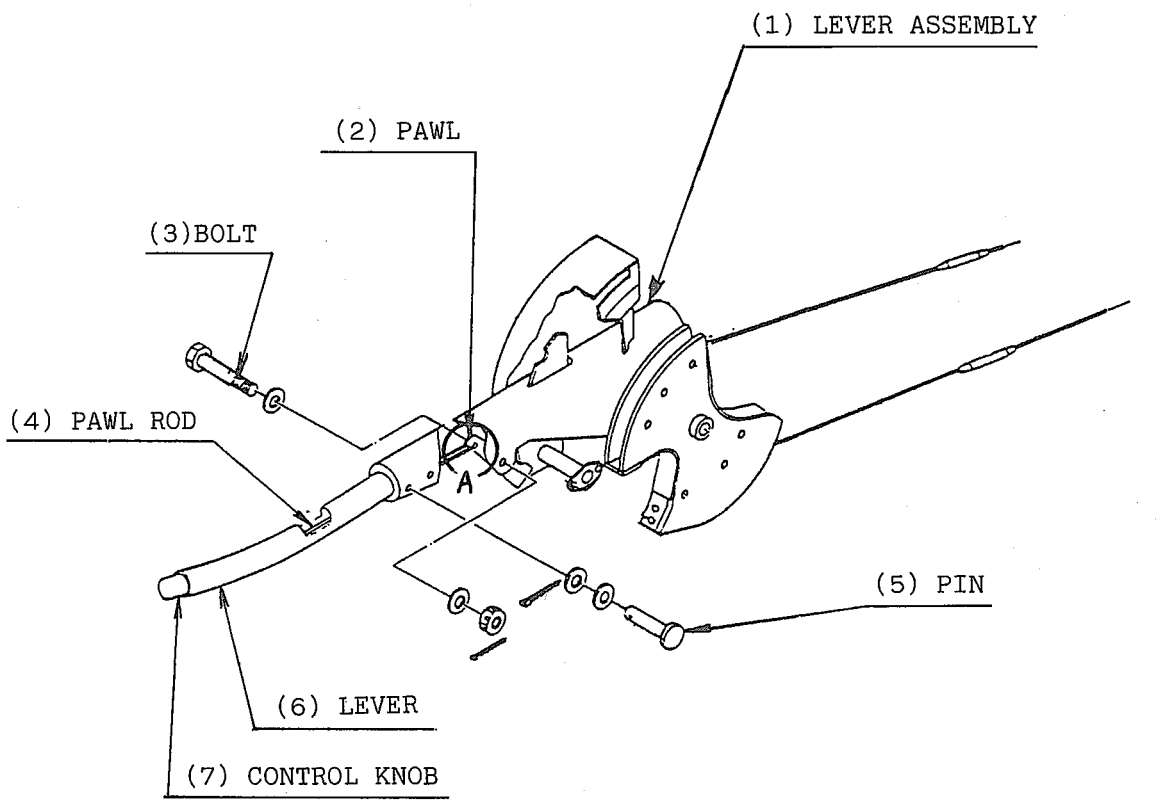
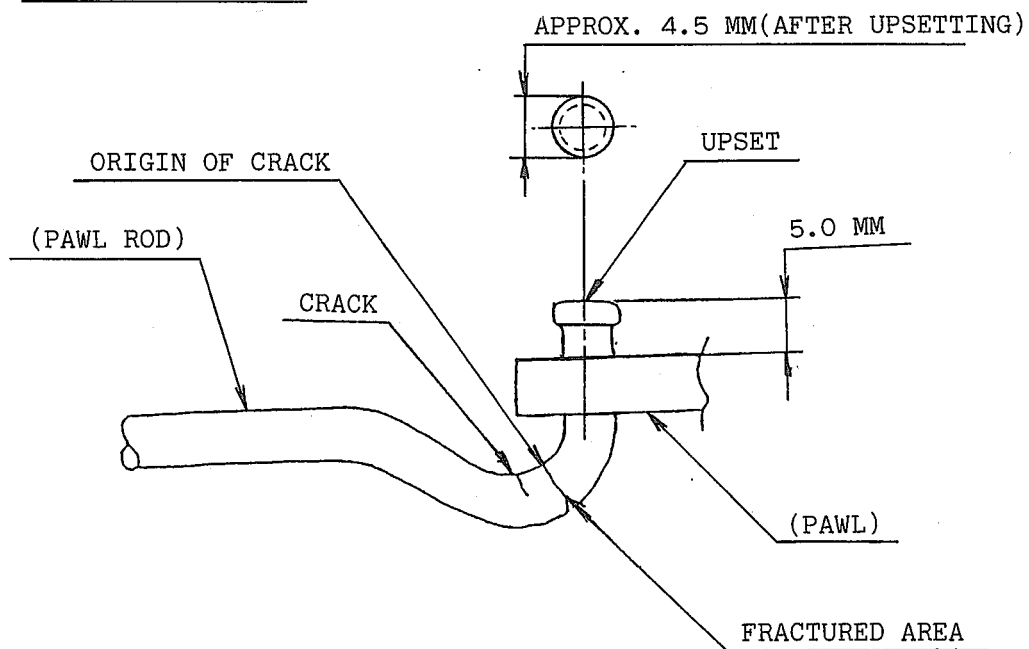
- (1) Move flap control lever "full down".
- (2) Clean pawl rod at detail "A", Figure 1, using naphtha or equivalent.
- (3) Using 10X magnifying glass, inspect pawl rod at detail "A", Figure 1, for crack.

- (a) Pay special attention to the internal bend radius area of pawl rod.
 - (b) Dye penetrant inspect suspected area if required for crack confirmation.
- (4) If any crack is found, replace pawl rod in accordance with para 12-2.

See Figure 1 for all items reference in this paragraph.

- (1) Move flap control lever "full down".
- (2) Remove bolt (3) connecting pawl (2) to lever assembly (1), and disconnect pawl (2).
- (3) Remove two pins (5) attaching lever (6) to lever assembly (1), and pull out lever (6) from lever assembly (1).
- (4) Pull out pawl rod (4) and control knob (7), as one piece, from lever (6) in the opposite direction.

Pawl rod (4) is inserted and bonded to control knob (7).

- (5) Remove pawl rod (4) from control knob (7).
- (6) Cut out upset end of pawl rod (4), and remove pawl (2).
- (7) Remove adhesive residues from control knob (7). Apply bond (A-6/A or equivalent to rouletted portion of new pawl rod (200-524405-003), and insert into control knob.

- (8) Apply bead of bond (A-6/A or equivalent) around the inserted pawl rod.
- (9) Insert pawl rod (4) through pawl (2), and upset end of pawl rod as shown in Figure 1, Detail A.
- (10) Insert pawl rod (4) and control knob (7) in the reverse order of the above step (4).
- (11) Install pawl (2) and lever (6) on lever assembly (1) in the reverse order of the above steps (2) and (3).
- (12) Move control lever full travel and check for proper operation.
