SERVICE BULLETIN

FUJI HEAVY INDUSTRIES LTD.

NO. 200-009

1. SUBJECT : Inspection and Repair of Elevator Torque Tube
2. AIRCRAFT AFFECTED : All FA-200 series aircraft S/N 12 and subsequent
3. PRIORITY : Essential.

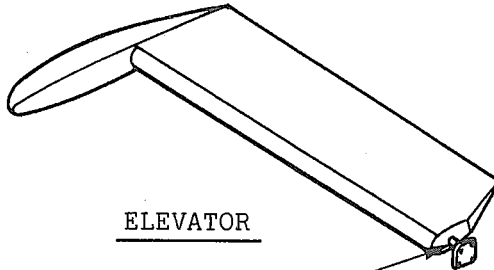
ELEVATOR

Thoroughly remove corrosion, particularly corrosion at the internal corner of flange. (See figure 1, area (A).)

- (1) Remove elevator in accordance with Service Manual, Paragraph 8-5-1.
- (2) Drill 30mm diameter hole in flange at the inboard end of elevator torque tube. (See figure 1, view C-C.)
- (3) Using a bore scope or mirror, inspect the internal surfaces of elevator torque tube for evidence of corrosion or unusual condition.
- (4) If no corrosion is found on the internal surfaces, proceed with step (10).
- (5) If corrosion is found, remove corrosion using wire brush or rotary brush.

After inspection and repair,
bond glass cloth to flange
surface.
