SERVICE BULLETIN

Fuji Heavy Industries, Ltd

NO. FAS-028

Addition of clamp for heating duct.

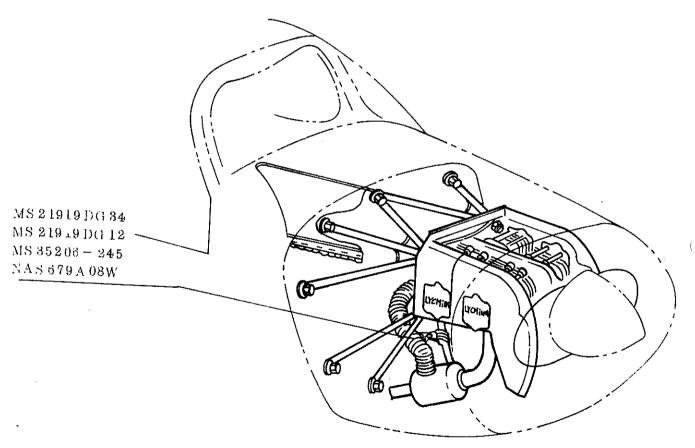
4. REASON: To prevent the contact heating duct and fuel

pipe together.

Clamp the heating duct to the Engine mount assy

- 1. Open the R. H. Cowling cover.
- 2. Remove the heating duct from R. H. Exhaust pipe to heating valve and the lacing which clamps fuel pipe.
- 3. Clamp the heating duct to the engine mount ass y (200-412010-003). (Refer to the following illustration)
